Global Journal of Environmental Science and Management (GJESM)

Rapid assessment of the riparian zone habitat of river

R.A.L. Amper*, G.R. Puno, R.C.C. Puno

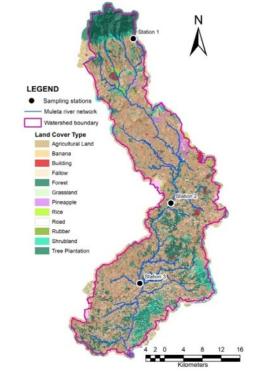
Fig. 4: Land cover of Muleta Watershed (Sentinel-2 2016 image)

The LULC of Muleta watershed was derived from Sentinel-2 2016 image using eCognition software. Generated map (Fig. 4) reveals that majority of the watershed is classified as agricultural land with cultivated crops. One km radius of the upstream area is surrounded by agricultural land (39%), shrubland (11%) and forest covers (42%) (Fig. 5). The water emanates from MKaNPK, a protected area declared
